**Indoor Air Quality**  
**Case Study**  
Roof Replacement  
Chemical and Particulate Exposures

## IAQ Case Study – Roof Replacement – Chemical and Particulate Exposures

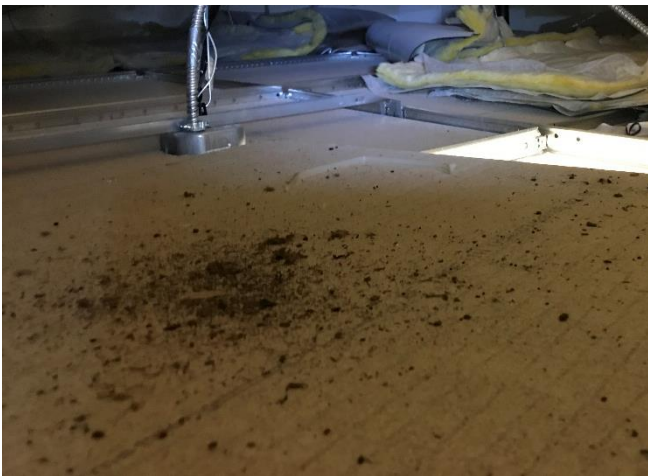
**Photograph 1:** Debris on top of ceiling tiles.

The ceiling plenum inspection and bulk characterization of dust from the top of ceiling tiles indicated debris had penetrated the roof deck during the roof replacement process. Lab results indicated high percentages of plant matter/trichome and presence of tar, wood chips, rubber particles, glue pieces, and concrete chunks.

2. Remove (bag) unnecessary insulation located on the top of ceiling tiles.
3. HEPA vacuum the top of ceiling tiles and their grid system, light fixtures, HVAC diffusers, and HVAC returns to remove debris from the ceiling plenum. Use proper remedial protocols.
