**Indoor Air Quality**  
**Case Study**  
Roof Replacement  
Chemical and Particulate Exposures

## IAQ Case Study – Roof Replacement – Chemical and Particulate Exposures

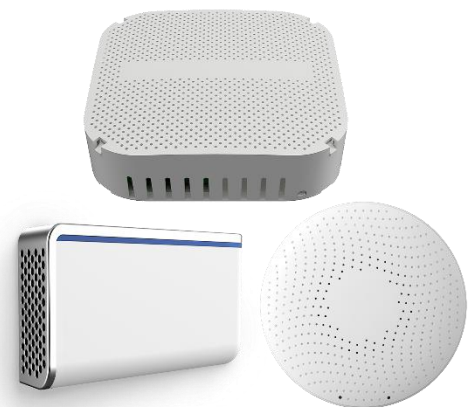
**Photograph 2:** IoT Multi-Analyte IAQ Dataloggers.

Following the IAQ investigation Edifice Rx was requested to provide remediation oversight and post remedial verification testing of the office space. In addition to a work plan review, onsite inspection and verification of HEPA air scrubber and vacuum performance, an internet of things (IoT) connected IAQ data logger was deployed in the office space for the duration of remediation. The data logger was moved daily following remediation work zones as the work progressed through the office (all remediation work was conducted after hours.) The IoT data logger provided real-time data for 9 IAQ analytes and real-time text message and email alerts if action levels were exceeded.
