Legionella Management for Building Water Systems

BY LAN CHI NGUYEN WEEKES, P.ENG., MEMBER ASHRAE; DONALD M. WEEKES, CIH, MEMBER ASHRAE

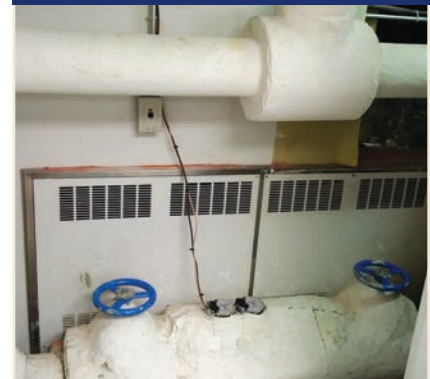
FIGURE 1 Dead leg (bottom) located in a closet in a basement.

The building operators are also invaluable to the team since they often know where cross-contamination/by-pass/dead legs in the water lines occur (Figure 1). This is especially useful when such a problem is located in a closet in the basement, or where most of the water systems are not located, like above the ceiling in an office. The building operators will often share their frustration due to the lack of access to certain equipment for maintenance purposes. They also will discuss peculiar maintenance practices such as throwing in a few pucks of chlorine now and then (no specific schedule) into the cooling tower water basins.

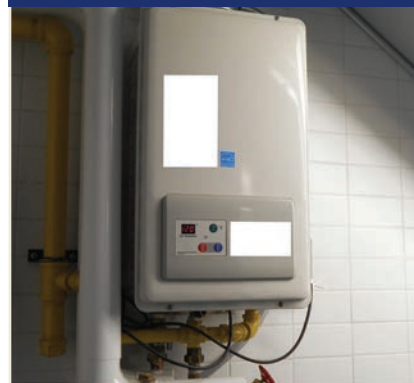
FIGURE 2 Tankless domestic water heater.

Different types of devices such as tankless water heaters and point-of-use small water heaters are becoming more prevalent in new and renovated buildings (Figure 2). Both types

of water heaters are used as energy saving alternatives to larger centralized hot water tanks. However, they carry different risks for the growth of *Legionella* bacteria.

Tankless water heaters generally heat the water at the point of use, and therefore they are eliminating water stagnation in a reservoir, which reduces the risk of *Legionella* growth. Although small water tanks at the point of use can limit water stagnation in the water line leading to the fixture, they can still have water stagnation in the tank at infrequently used locations. Moreover, they generally do not have any means for water recirculation or water temperature control. Close monitoring of point of use equipment (especially small water tanks) is essential since they tend to be located in areas that are not visible (under kitchenette counters) or inaccessible (ceiling-mounted).
